Manhole Inspection Summary

Manhole # S09UU_007MH

Insp Date: **8/11/08 2:25 PM**

Location Address: **3200 HILTON ST**

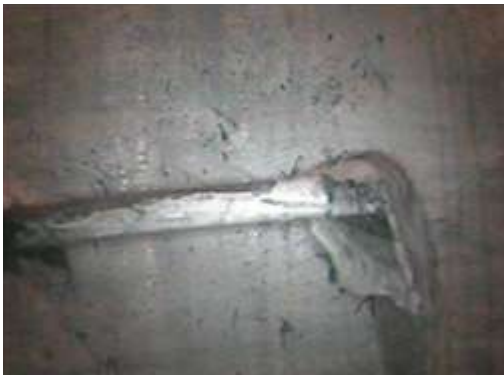
Defect 1

Surcharge ☒ **Evidence Of Surcharge** Depth: **3** (ft.) ☐ Active Surcharge Present

SURCHARGE/DEBRIS ON RUNG.

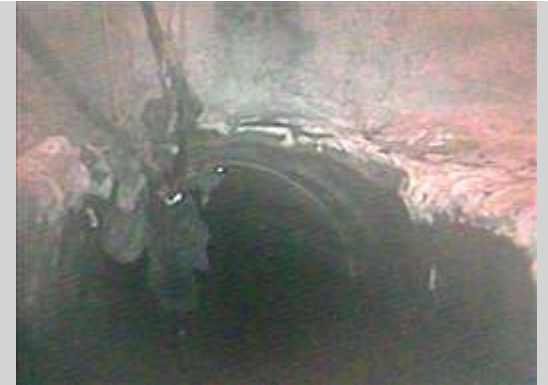
12 O'Clock Outflow

10 in. Circular Gravity Sewer
Pipe Out @ 12 O'Clock

SURCHARGE/DEBRIS ON RUNG.

Infiltration: **None** Pipe Seal Cond: **Sound**

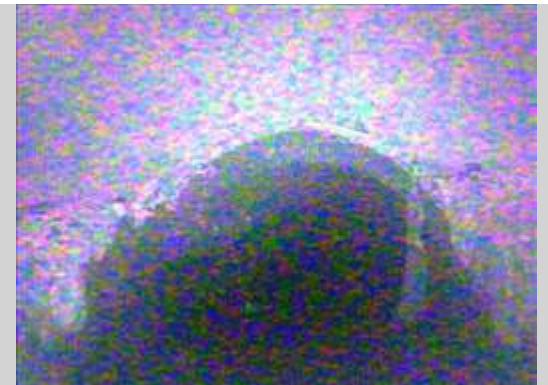
6 O'Clock Inflow

10 in. Circular Gravity Sewer
Pipe In @ 6 O'Clock

Infiltration: **None** Pipe Seal Cond: **Sound**
